#### Newsletter

# Warwick Equine Veterinarians

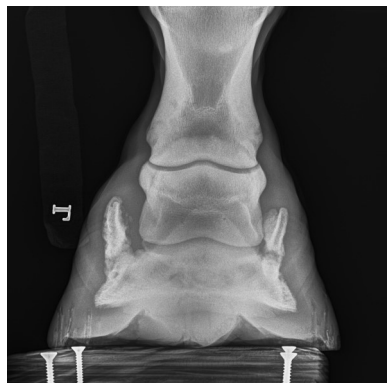
In the scans of the forefeet above it is apparent that there is more black (increased uptake of the radiopharmaceutical or "hot spots") in the sidebone of the left fore, and more in the distal pedal bone on the right. When we bring together this information with the x-rays of the feet, we can start to feel more confident of our diagnoses and develop a plan for management.

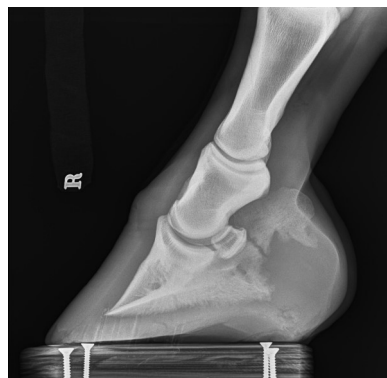
In x-rays of the left fore, the very large sidebones are apparent. Some horses have these with very little or no clinical adverse effects, but in this case it is likely these are causing some pain and lameness.

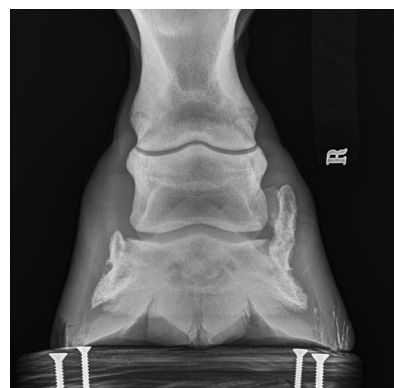
In the right fore a very large sidebone is apparent but this is relatively quiet on the bone scan,

however, there is evidence of inflammation and demineralisation in the lateral part of P3. This is the "club foot" so it is not so surprising. In this case the combination of imaging gives us a good understanding of the issues in the feet of this horse and allows us to develop a management plan, which will to a large extent involves managing the biomechanical problems of the region with careful shoeing.

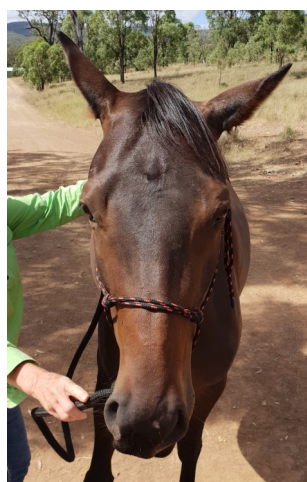
This was a case of a mare which was being locked in a yard due to a leg injury. It was a very safe post and rail yard but one morning she was found with these signs. As you can see the left ear is droopy, the left eye is partly closed and the nose is pulled to the right. These are all signs associated with damage to the facial nerve. In this case we postulate she must have had her head through the rails and pulled back vigorously and damaged the nerve. The facial nerve can be damaged anywhere along its course from the brain, in this case we thought it was quite early in its pathway as not only did we have the typical nose deviation but also the eye and ear signs. These can regenerate and improve, but often it can take a long time. In this case because the damage was quite early in the course of the nerve, there was concern that another complication, dry eye, could also occur. Fortunately tear production has returned and we only needed to manage that problem for a short time. Although not all cases will regenerate the nerve, this case is doing well and gradually the nerve function is returning.
